Spindle
Technology

Detecting Torsional Defects in a Gear Driven Spindle.

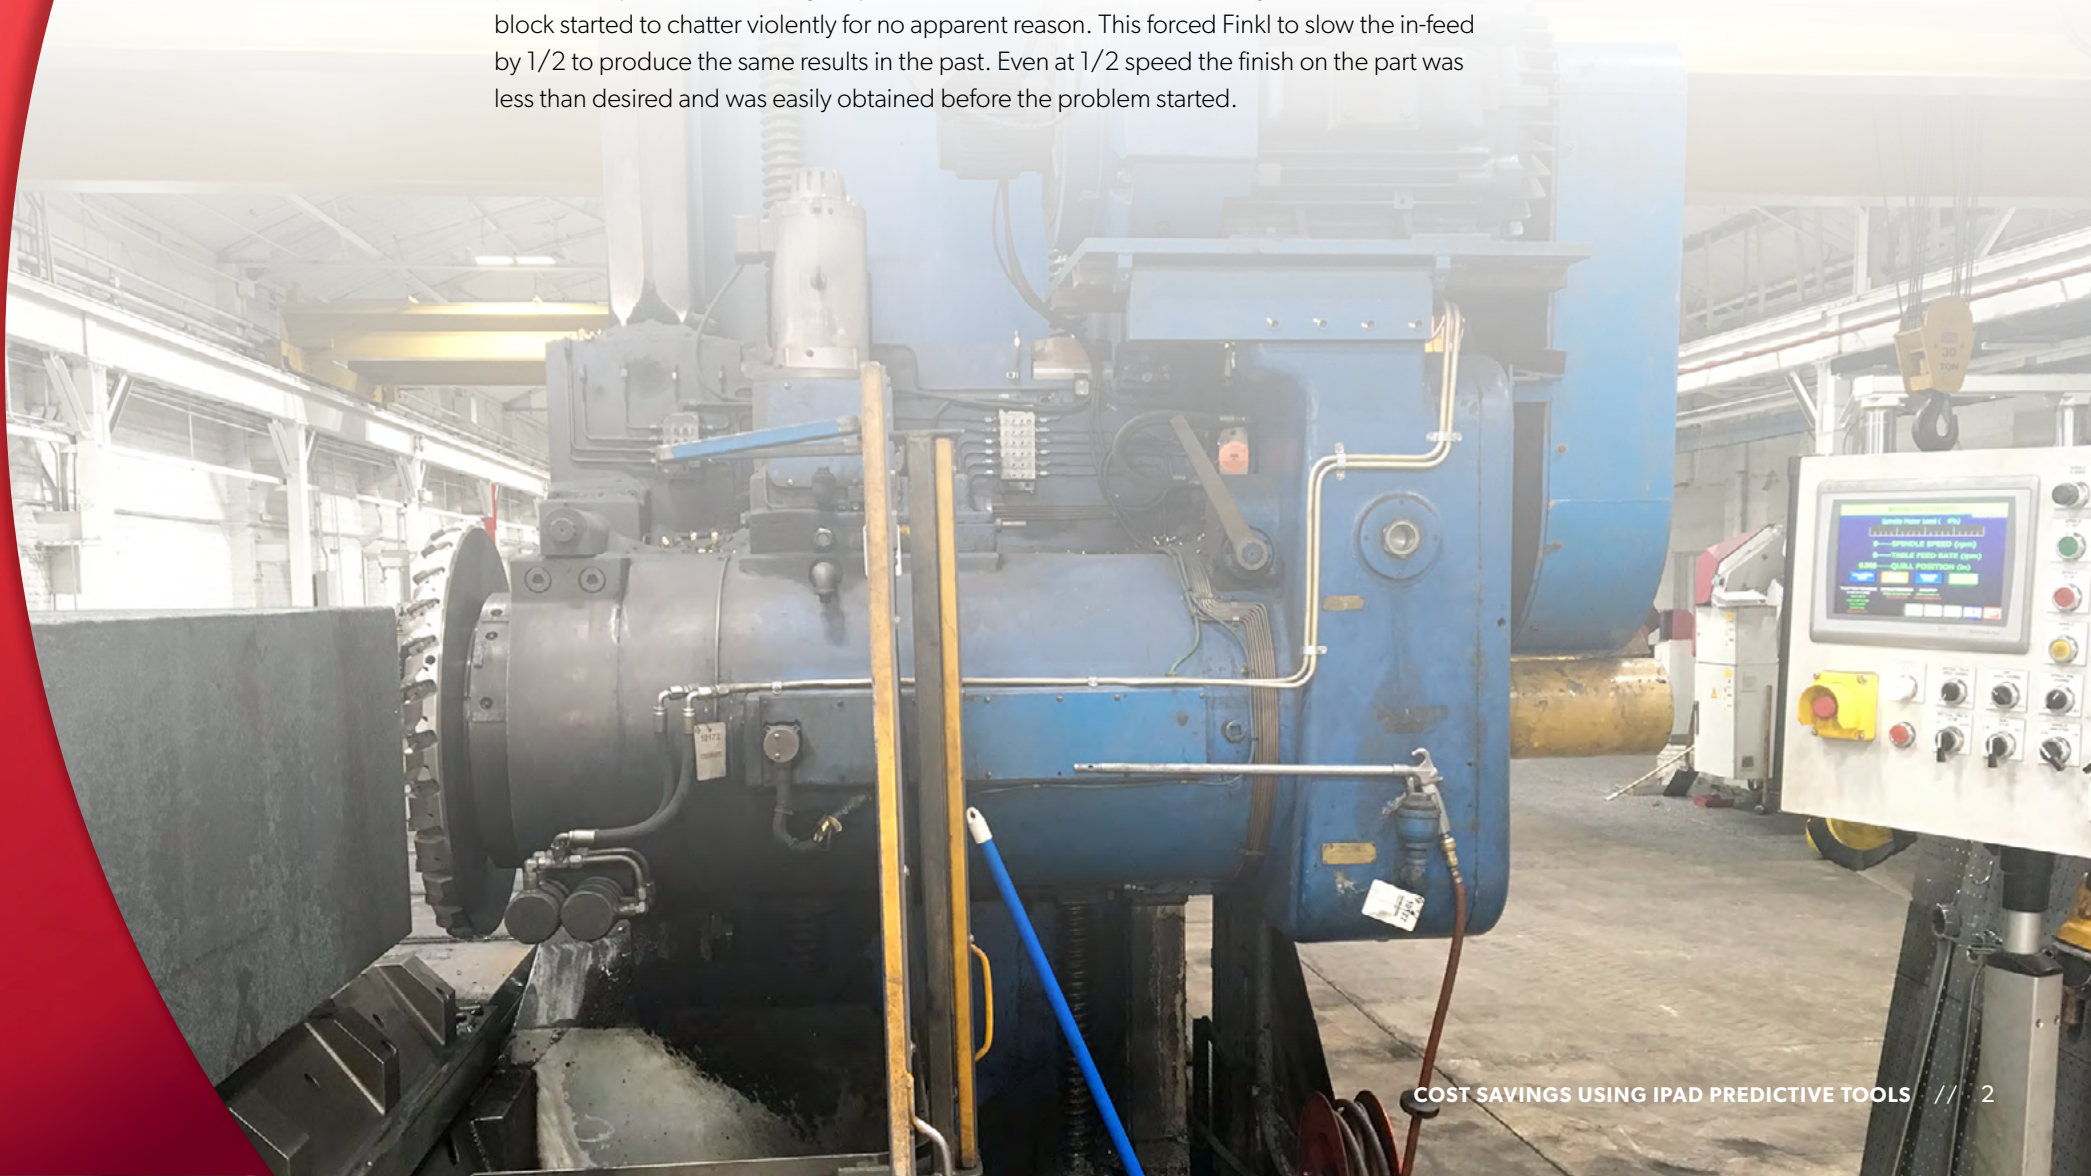
GTI was referred by Ingersoll Production Systems to investigate an ongoing problem on a face milling operation at Finkl Steel in Chicago IL. The application in the photo below was a process they have been doing for years on this machine. The face milling of a several ton steel block started to chatter violently for no apparent reason. This forced Finkl to slow the in-feed by 1/2 to produce the same results in the past. Even at 1/2 speed the finish on the part was less than desired and was easily obtained before the problem started.

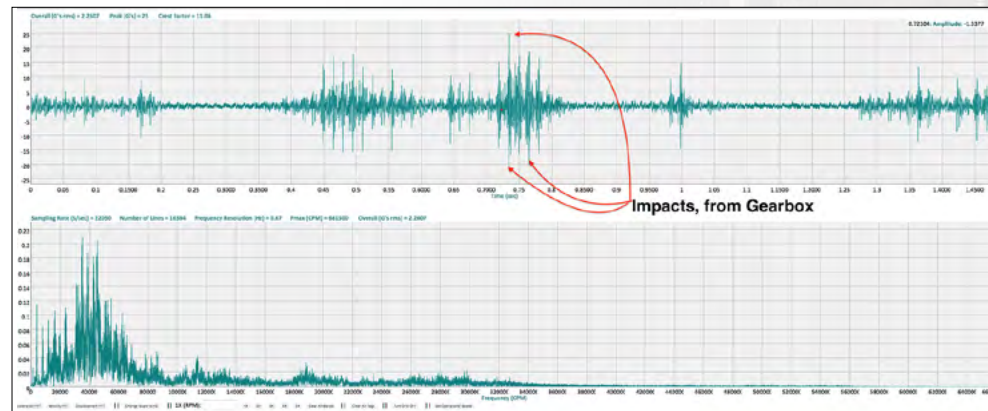
We then induced the noise and chatter by speeding the feed rate up and took a measurement. (while cutting) This is when we finally saw the defect in the vibration signature. (see below)

When running without load the amplitude was .3493 G's Overall RMS. As you can see above when the vibration is induced under load/cut it rises to 2.26 G's RMS and has peaks up to 25 G's.

Two things were conclusive from all the tests we at GTI conducted. #1 the vibration clearly had the most amplitude emanating from the gearbox. #2 The spectrum and wave form was clearly showing a torsional defect/impact in the gearbox.

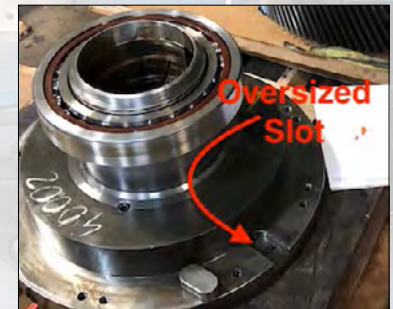
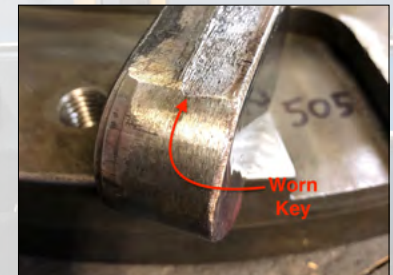
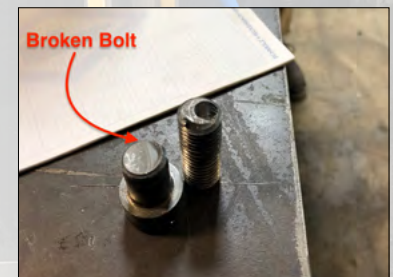
We found 1 of the 8 final drive gear assembly bolts broken and several others loose. We also found the keys for the final gear assembly to be worn and the slots they sit in were worn oversized from the torsional chatter. (See Photo's to the right) Both the gear and the hub show this clear defect.
